NASA CR-121188
AL73T024

HIGH TEMPERATURE LUBRICANT SCREENING
AND SYSTEMS STUDIES

David A. Jones
SKF INDUSTRIES, INCORPORATED

NASA Lewis Research Center
Contract NAS3-14320
William R. Loomis, Project Manager

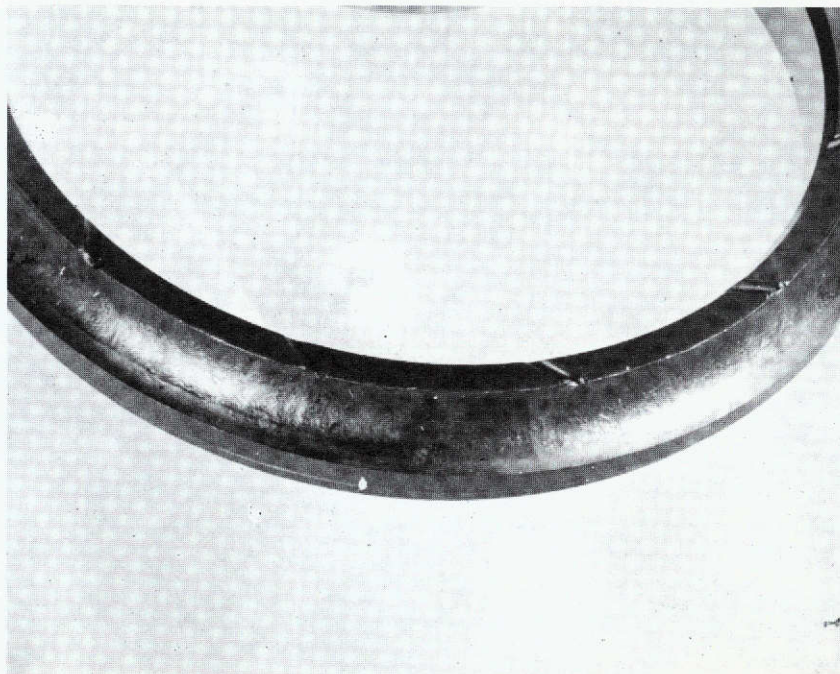
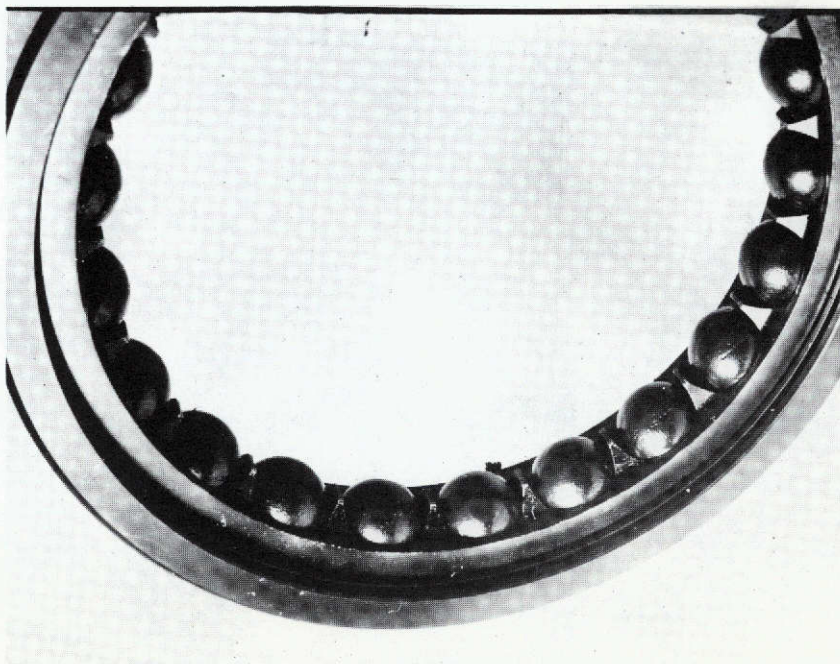
ENCLOSURE 35

TEST BEARING COMPONENTS AFTER SCREENING TEST USING MONSANTO MCS-2931
OIL AT SPEEDS TO 21,900 RPM

The split inner ring test bearing gave excellent performance throughout the program. The one failure experienced was of the smearing type and was attributed to the Monsanto MCS-2931 oil rather than to the bearing.

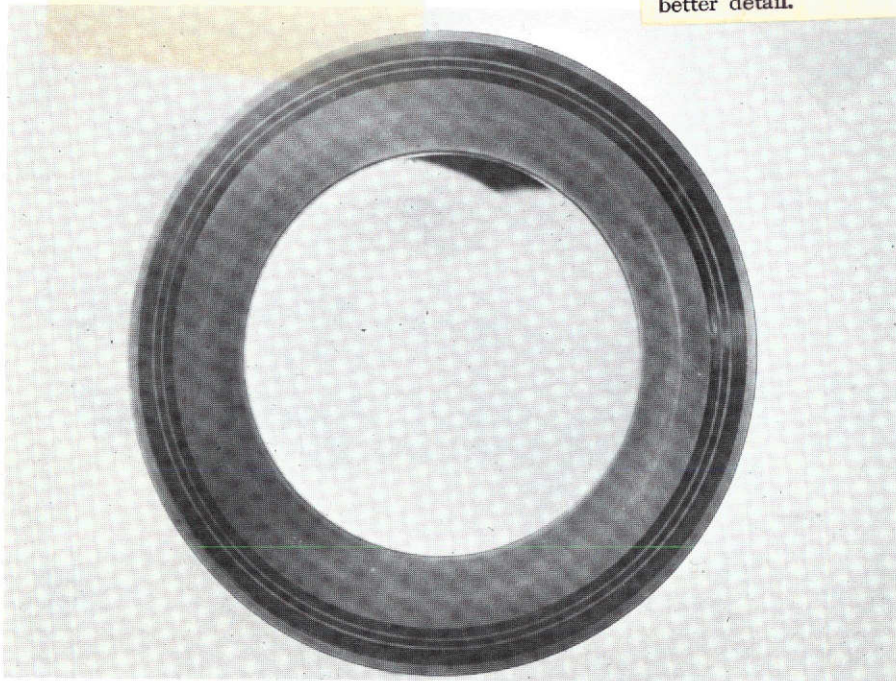
ENCLOSURE 52

AIR SEAL AND MATING RING AT COMPLETION OF REPEAT EXTENDED DURATION
TEST USING HUMBLE FN-3158 OIL BLENDED WITH 5% KENDALL 0839 RESIN
AFTER 6.3 HOURS AT SPEEDS TO 20,100 RPM
